**BRIDGE DECK RESTORATION
METHODS AND PROCEDURES**

PART I

REPAIRS

Interim Report

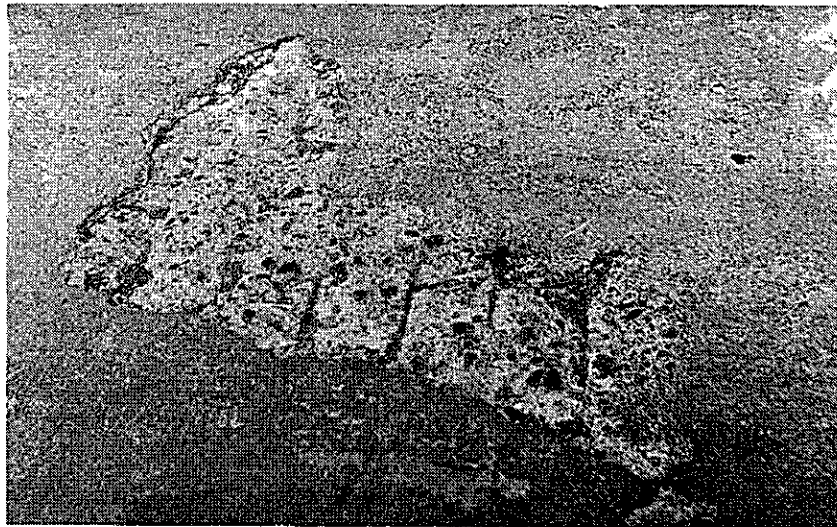
Figure 1

Bridge Deck Pothole

Potholing is the first visual manifestation of serious deck deterioration. Unless the deterioration is checked, the process continues until the lower mat of steel is also affected. The end result is a complete break out of the deck.

Salting to prevent icing in the mountains or frost in the valleys is causing premature bridge deck deterioration in California. When deicing salts reach the deck reinforcing steel, an electrolytic action begins which causes some steel to corrode. As the corrosive particles build up they expand against the concrete covering the steel. As the process continues, the tensile strength of the concrete is exceeded and intermittent cracks radiate out horizontally from the top mat of steel forming what is commonly referred to as an undersurface fracture. Traffic impact causes the concrete above the undersurface fracture to eventually break up and ravel out leaving a pothole in the deck surface and exposed reinforcing steel, see Figure 1. These potholes are hazardous, unsightly and costly to patch.

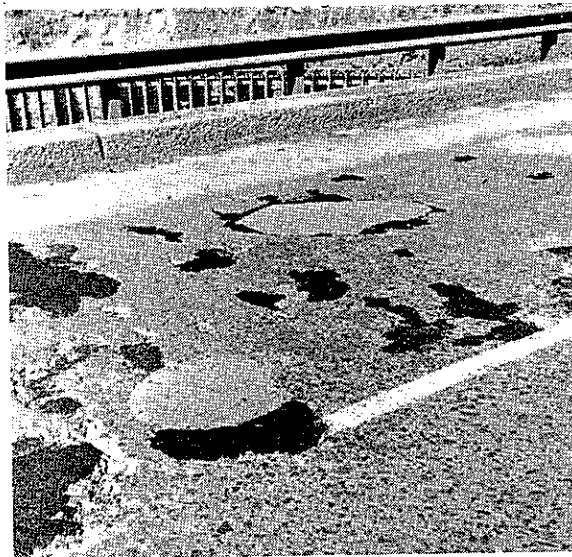
Figure 2

Unsightly Deck Patches

Patching the same area or just outside the periphery of previously placed patches becomes very costly. The continuous formation of potholes and the long exposure of potholes in the winter months constitute a continuous traffic hazard. In addition to being costly and hazardous, the practice of just patching potholes as they occur is undesirable due to their very unsightly appearance. See Figure 2.

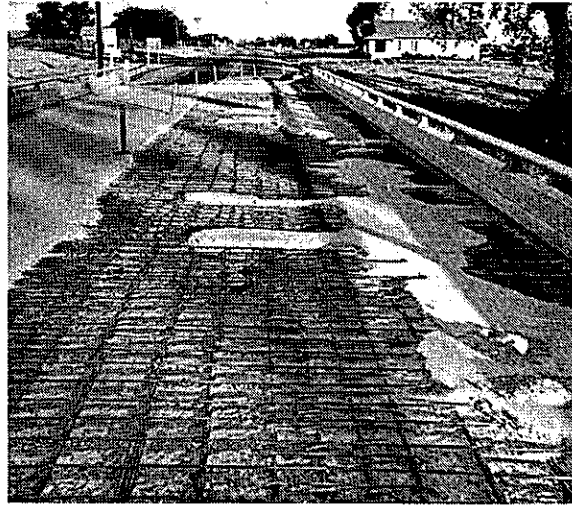
Figure 4

Excessive Concrete Removal

Some decks reach a stage of deterioration that makes the normal restoration practice on them more costly than a complete replacement, when life expectancies are taken into consideration. See Figure 4. This fact suggests that there is a transitional area where something less than the normal

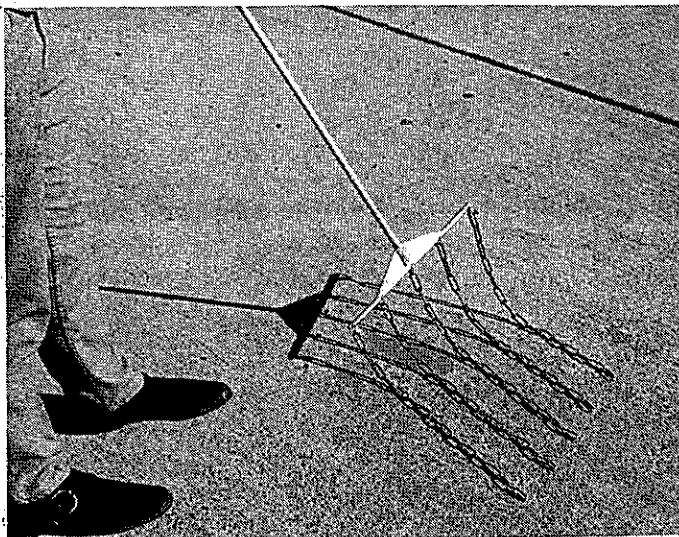
The broom shaped chain drag shown in Figure 6 has proven to be a very effective sounding device. Its greatest

Chain Drag for Detecting
Undersurface Fractures

attribute is that large areas can be rapidly covered with a sweeping motion. As an added feature, this device will detect undersurface fractures which cannot be detected by striking the surface with a hammer or rod.

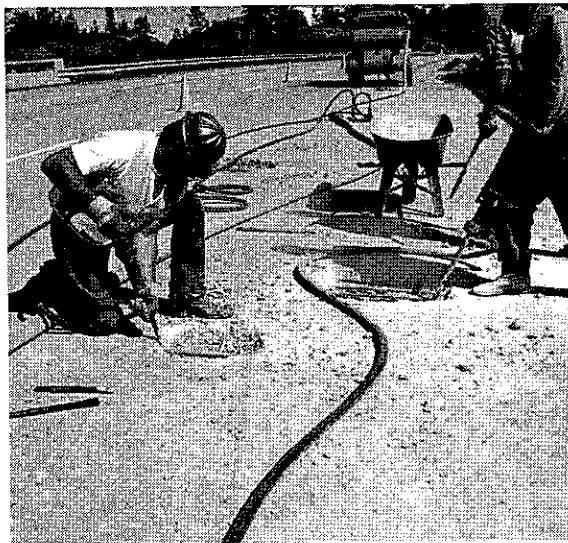
Figure 8

The size of jackhammer to be used in removing fractured concrete during restoration is to some extent dependent upon the skill of the operator. Experience has shown however that the maximum size should be no more than 65 pounds for the initial breakout, regardless of the operator's skill. For less skilled operators the maximum should be 30 pounds. Final clean up of small areas which were fractured by the larger jackhammers should be removed with a small air powered chipping gun. See Figure 8. Or if preferred, the final

Initial Breakout With a Jackhammer -
Finishing With a Chipping Gun

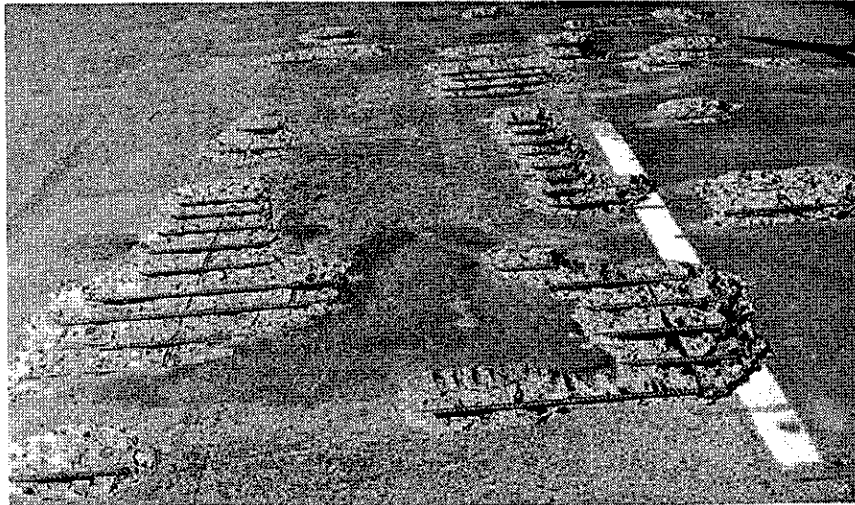
Figure 9

In fractured areas, the concrete should be removed 1" below the steel which is corroded. The primary purpose of this depth is to facilitate painting the reinforcing steel with epoxy. See Figure 9.

Undersurface Fractured Areas
Prepared for Patching

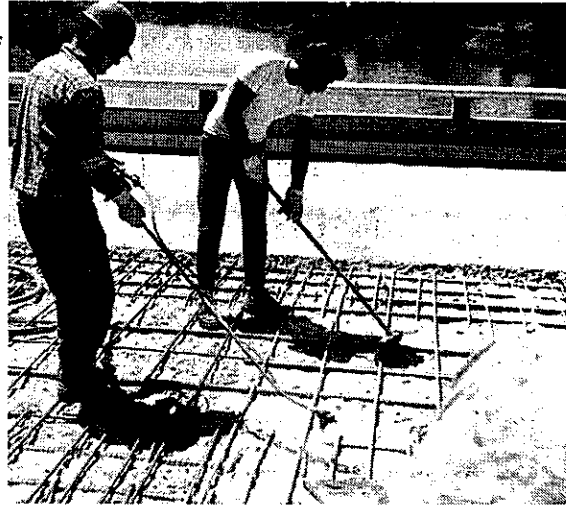
Figure 12

An epoxy bond coat can be either sprayed or brushed in place. Generally, when sprayed, a follow-up brushing is necessary to preclude holidays on both the concrete and steel, especially the underneath portion of steel, and excessive build-up in low spots of the concrete. See Figure 12. A distinct

Spray Applied Epoxy Bond Coat -
Smoothed By Brush

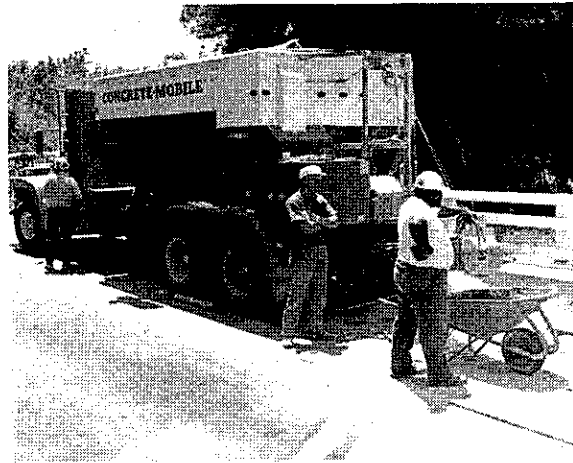
does introduce some problems on restoration jobs it will be discussed. Figure 13 shows the mobile mixer.

Concrete Mobile -- A Self-Contained
Concrete Mixer

Mixing time in the auger is only 12-15 seconds. This short a mixing time frequently results in a false set or a premature stiffening of the discharged concrete, thereby making it difficult to place and finish. The normal tendency is to overcome this problem by adding more water. This does not accomplish the objective as false set continues to occur. The only accomplishment is an overly wet mix which results in poor compressive strength and excessive shrinkage cracking. The proper method of correcting false set is by vibration or working the mix. Hence, if false set becomes a problem during patching, the mix should be thoroughly worked or vibrated before it is placed and finished.

9. The continuous type concrete mobile mixers cause false set or premature stiffening of the discharged concrete.

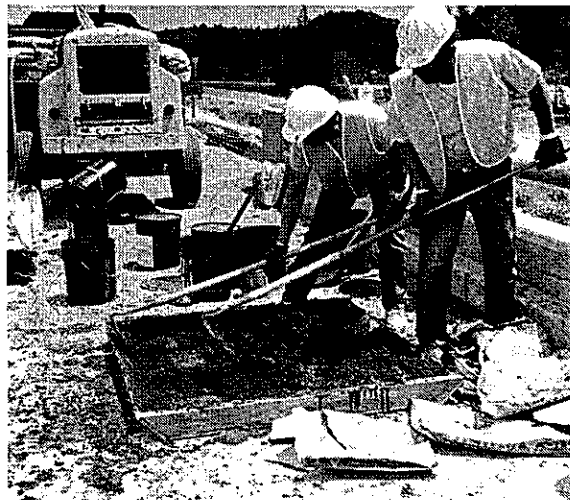
Figure 14

Epoxy concrete is usually mixed by hand in a mortar box (Figure 14) or mechanically in a pug mill. In either case

Hand Mixing Epoxy Concrete
in A Mortar Box
